Navajo Abandoned Uranium Mine

Site Screen Report

Saytah AUM Site

August 2010

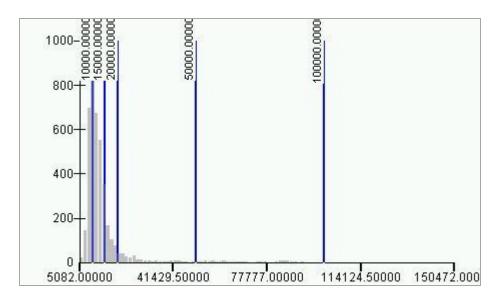
The following chart and statistics were generated by ESRI ArcGIS 9.3.1, and show the general distribution of the site gamma radiation measurements. The horizontal X axis represents the gamma radiation reading levels in cpm (lowest levels to the left). The vertical Y axis represents the frequency of each gamma radiation level.

4062 Count: Minimum: 5082.00000 Maximum: 150472.00000 Sum: 60845112.00000 Mean: 14979.10192 Median: 11532.50000 Standard Deviation: 13377.50052

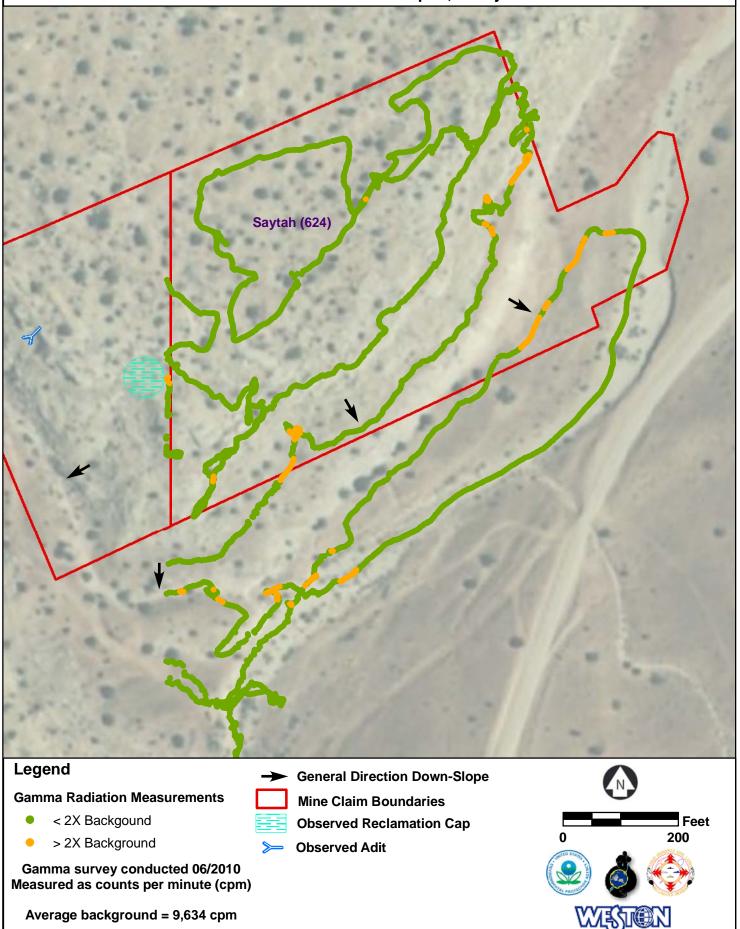
Figure 1 - Gamma Radiation Measurements, Above Two Times Background
Saytah (624)
Sweetwater / Teec Nos Pos Chapter, Navajo Nation

A total of 4,062 gamma radiation measurements were collected from the mine site, ranging from 5,082 cpm to 150,472 cpm. The measurements are represented in Figures 1 and 2.
